**CALSPAN ON-SITE AMBULANCE CRASH INVESTIGATION**

**SCI CASE NO.: CA12032**

**VEHICLE: 2009 CHEVROLET C4500 / ROADRESCUE TYPE I AMBULANCE**

**CRASH DATE: JULY 2012**

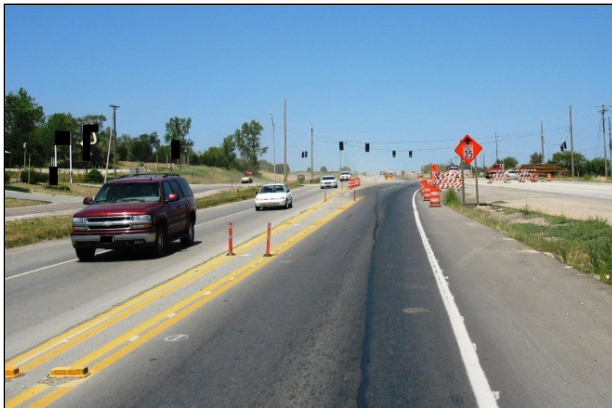
**Figure 2:** North-facing view of the ambulance's pre-crash trajectory and the construction zone.

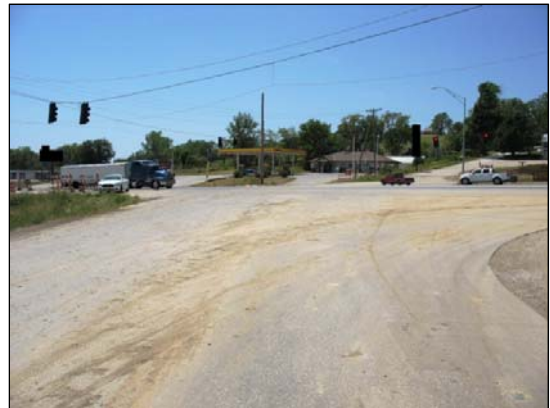
**Figure 3:** West-facing view of the Ford's pre-crash trajectory.

The dump truck and Ford traveled west toward the intersection. Both lanes of the east leg were 4.5 m (14.8 ft) wide and delineated by a double-solid yellow centerline. **Figure 3** depicts a view of the vehicles' westbound trajectory toward the intersection. The Speed was regulated in all directions by a posted limit of 80 km/h (50 mph). A Crash Diagram is included on page 19 of this technical report.

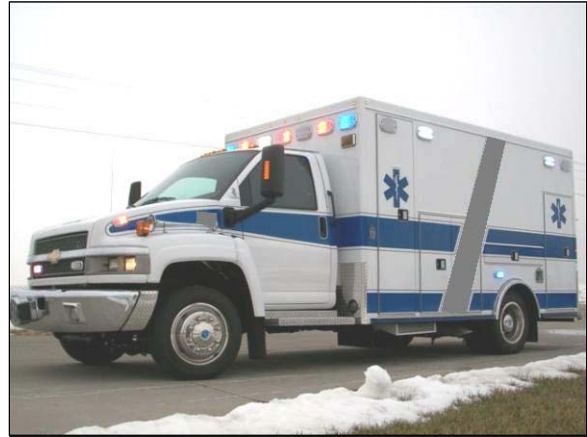
**Figure 6:** Front left oblique view of the completed 2009 Chevrolet C4500 / RoadRescue Type I ambulance (image obtained from the manufacturer).

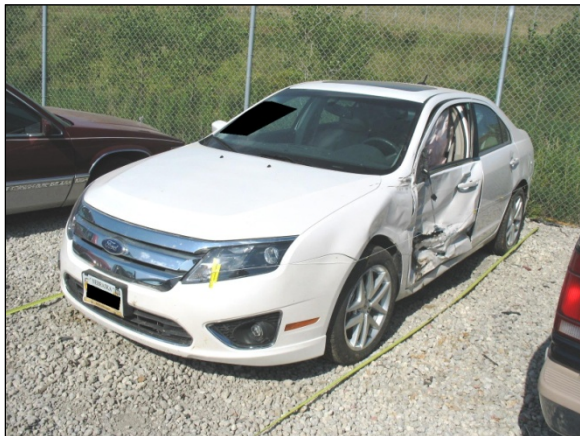
The 2012 Ford Fusion (**Figure 15**) was a white sedan identified by the VIN: 3FAHP0JA7CRxxxxxx. It was powered by a 2.5 liter, 4-cylinder gasoline engine. The Ford had a 273 cm (107.5 in) wheelbase and a reported curb weight of 1,650 kg (3,638 lb). It was configured for the seating of five passengers, and was equipped with 3-point manual lap and shoulder belts for all seating positions.

**Figure 15:** Left front oblique view of the 2012 Ford Fusion.
